Case Head Separation

Rev. 3

This article addresses a relatively common problem that occurs with 375H&H.

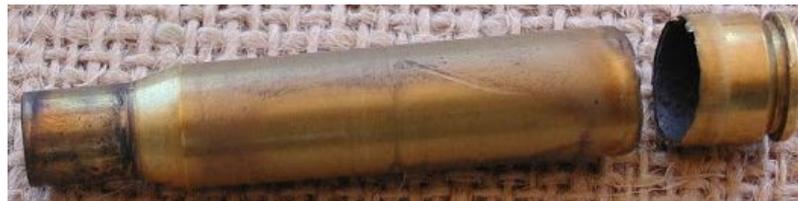
1. The ruptured case head is ejected, and the case remains in the chamber causing a jam if another round is chambered behind that one. This can be resolved by removing the bolt, and manually extracting the round as well as the ruptured case. The case portion often just drops out when the rifle is held vertically. If the case remains in the chamber, then a cleaning rod with a jag with a 2x4 wrapped around it, can be forced into the case and then the case pulled out the chamber. If a bore-snake is available, this can be inserted from the muzzle side and pulled through the barrel, which will dislodge the case portion. Figure 1 below shows a ruptured case with the case-head as a separate portion.

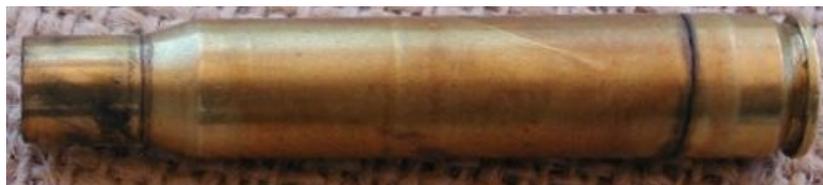
2. The partially ruptured head and case are ejected safely, and the shooter carries on without even noticing anything untoward. This leads to a good discussion of what happened as well as a good lesson why reloads are NOT to be used when Guiding! Figure 2 below shows the case-head still attached to the case, but with an obvious "break" in the case itself.

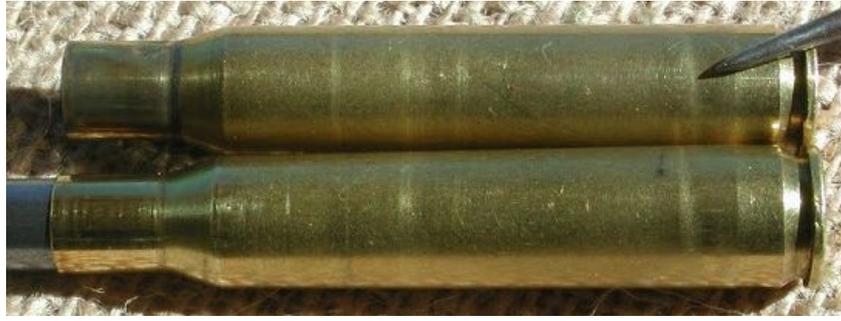
Figure 3

1. It can be that the case has been reloaded too many times. During the reloading process, a die is used to resize the case back to its original specification to ensure that it chambers correctly in the rifle. Part of this process involves resizing the external dimensions of the case as well as the internal neck. When the neck is resized, an expander ball is pulled upwards pressing the internal portion of the neck against the side of the die. This process also "pulls" the brass from the bottom, or web of the case. The web starts getting thinner and thinner after every resize until a shiny ring can sometimes be noticed, indicating that a case head separation is imminent. See figure 3 below.

2. The second and possibly the more common reason is that the headspace of the action is too loose. This can only be checked using a NO-GO gauge. If the bolt closes on the NO-GO gauge, then the headspace is too loose, and the rifle needs to be urgently sent to a proficient gunsmith so that the problem can be resolved. This will be a relatively expensive exercise as the barrel needs to be removed and a complete turn taken off the face of the barrel and then the chamber rebores.

Plainly, when this “shiny ring” is noticed, the case should be immediately rejected. However, the “shiny ring” is not always obvious!

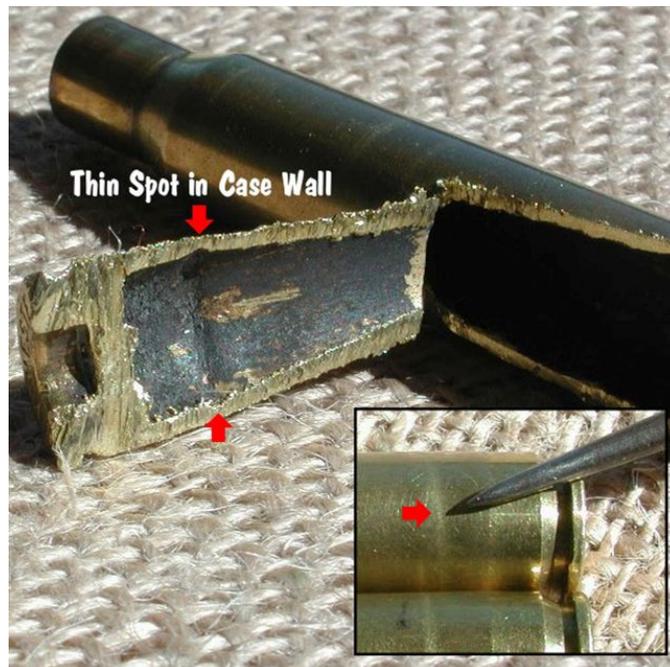
Figure 4

If we look inside a case that is about to have a head separation, we can clearly see the thin spot as indicated in figure 4 below. It is obvious that the internal portion is not easily identified and that is why this can occur without an obvious warning sign!
