Case Head Separation

Rev. 3

March 2022

This article addresses a relatively common problem that occurs with 375H&H.

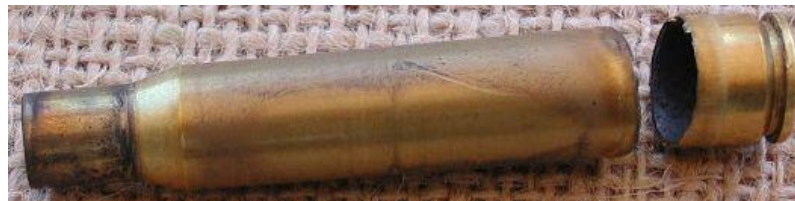
1. The ruptured case head is ejected, and the case remains in the chamber causing a jam if another round is chambered behind that one. This can be resolved by removing the bolt, and manually extracting the round as well as the ruptured case. The case portion often just drops out when the rifle is held vertically. If the case remains in the chamber, then a cleaning rod with a jag with a 2x4 wrapped around it, can be forced into the case and then the case pulled out the chamber. If a bore-snake is available, this can be inserted from the muzzle side and pulled through the barrel, which will dislodge the case portion. Figure 1 below shows a ruptured case with the case-head as a separate portion.

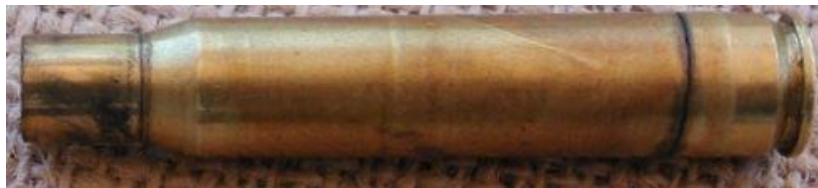
2. The partially ruptured head and case are ejected safely, and the shooter carries on without even noticing anything untoward. This leads to a good discussion of what happened as well as a good lesson why reloads are NOT to be used when Guiding! Figure 2 below shows the case-head still attached to the case, but with an obvious “break” in the case itself.

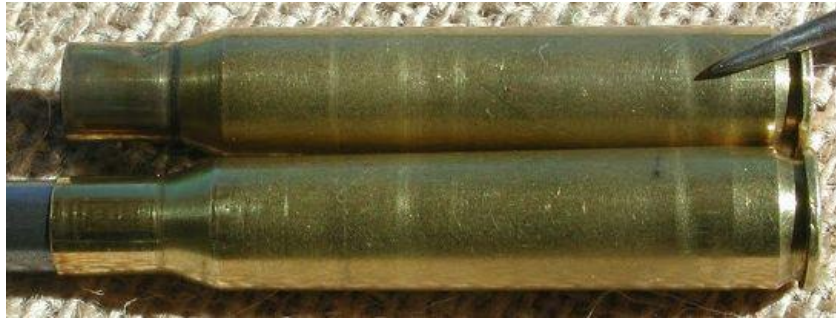
Figure 3

1. It can be that the case has been reloaded too many times. During the reloading process, a die is used to resize the case back to its original specification to ensure that it chambers correctly in the rifle. Part of this process involves resizing the external dimensions of the case as well as the internal neck. When the neck is resized, an expander ball is pulled upwards pressing the internal portion of the neck against the side of the die. This process also “pulls” the brass from the bottom, or web of the case. The web starts getting thinner and thinner after every resize until a shiny ring can

sometimes be noticed, indicating that a case head separation is imminent. See figure 3 below.

Plainly, when this “shiny ring” is noticed, the case should be immediately rejected. However, the “shiny ring” is not always obvious!

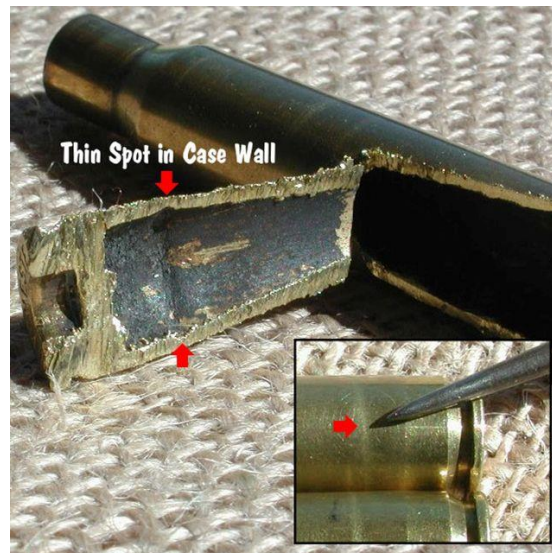
Figure 4

If we look inside a case that is about to have a head separation, we can clearly see the thin spot as indicated in figure 4 below. It is obvious that the internal portion is not easily identified and that is why this can occur without an obvious warning sign!
